Massachusetts Turnpike

5 Year Reconstruction and Improvement Program

Summary Report 1992

HOWARD NEEDLES TAMMEN & BERGENDOFF
ARCHITECTS ENGINEERS PLANNERS

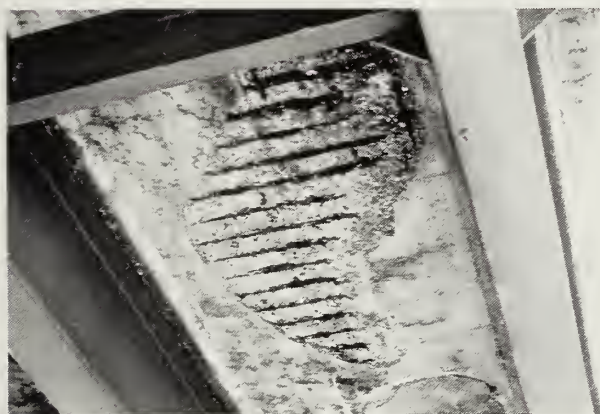
Underside of Bridge Deck with Corroded Reinforcing Exposed

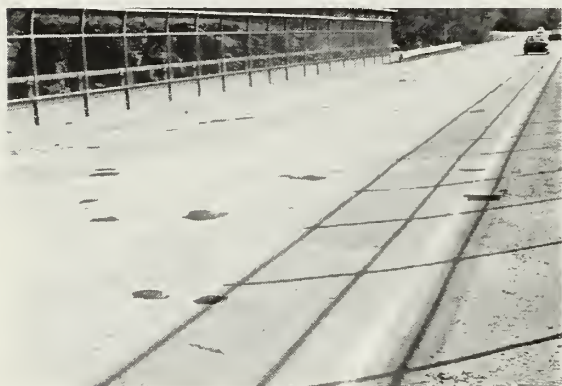
*Typical Deck Deterioration
Marginal/Poor Condition (Category 4)*

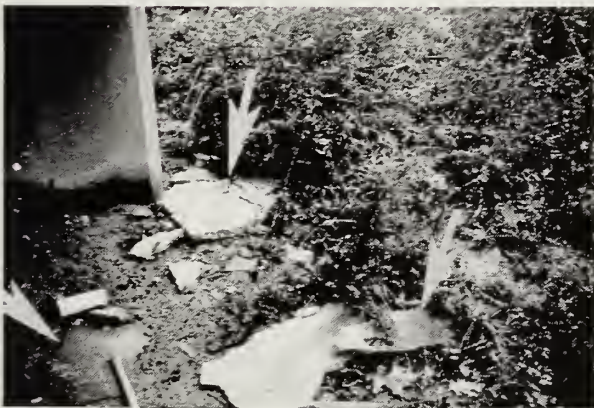
Concrete Debris from Underside of Bridge Deck

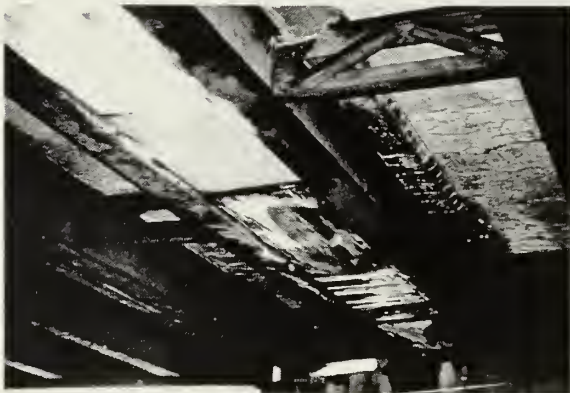
*Bridge Shielding and Deck
Deterioration Closeup*

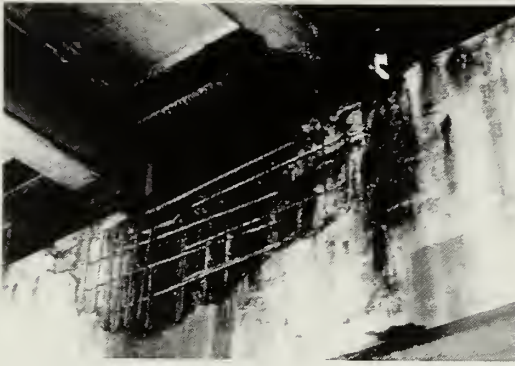
Substructure Deterioration at Bridge Abutment

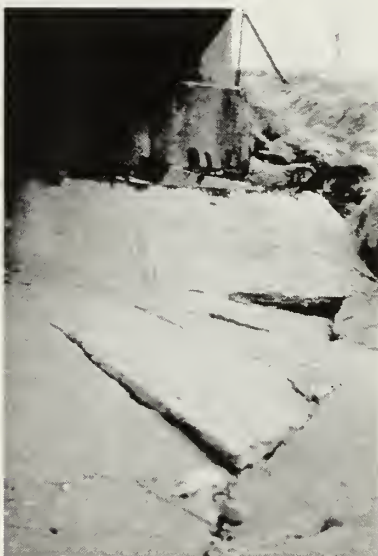
Slope Paving Failure

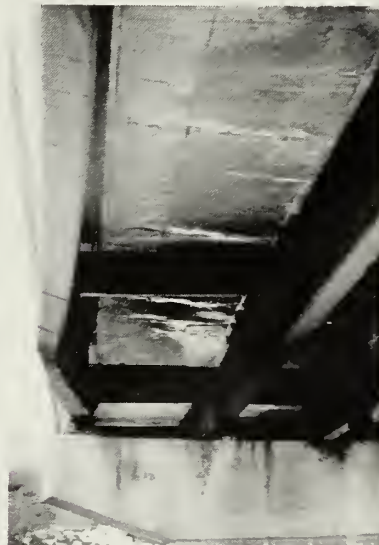
Example of Bridge Damage and Deterioration

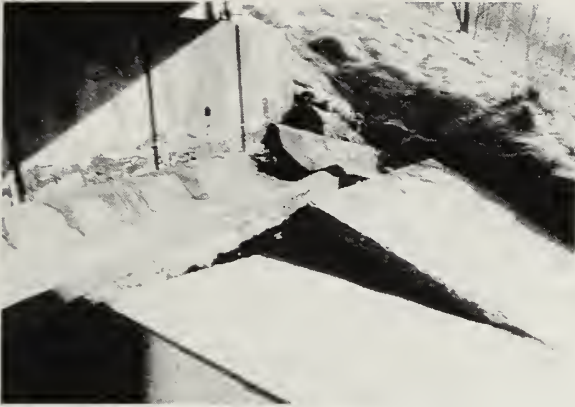
Typical Slope Paving Undermining and Settlement (Substructure Repair)

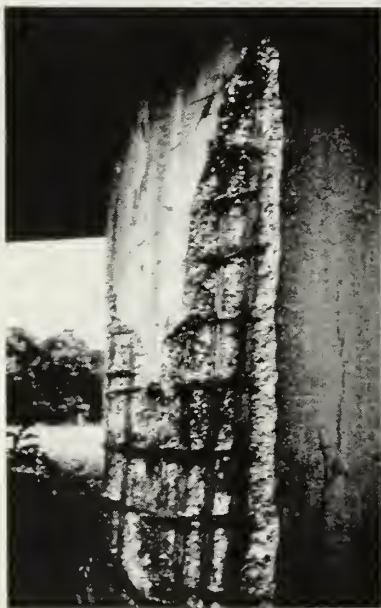
The substructure of numerous bridges, including the slope paving, drainage gutters, piers and abutments, are in critical need of improvement. In a number of instances, this need for reconstruction has become critical. The substructure elements of a bridge provide the foundation and support for the entire deck and superstructure, and while they generally are not visible to the travelling public, the structural integrity of these elements is absolutely essential to the safety of the structure. The Authority's maintenance forces are doing some essential repairs to deteriorated substructure concrete. However, the extent and number of locations where rehabilitation of substructure concrete is needed indicates that a more comprehensive and scheduled rehabilitation program is required in order to prevent further deterioration and damage.

*Substructure Deterioration at
Bridge Pier*

As part of the bridge deck replacement and deck rehabilitation work, these substructure elements will be repaired on a priority basis and coordinated with other bridge reconstruction activities wherever possible. Substructure rehabilitation for those bridges that are not scheduled for deck replacement or rehabilitation, will be performed where required under separate contract. Failure to perform this work on an accelerated basis can result in a more rapid deterioration of the substructure and a dramatic escalation in the costs of the rehabilitation.

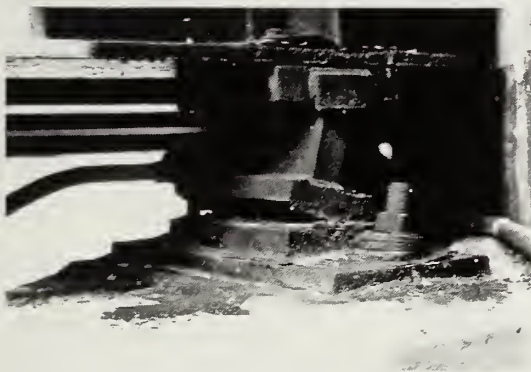
Many of the bridges on the Turnpike have experienced deterioration of the bridge bearing devices that support the bridge superstructure as the result of corrosion, weathering and accumulations of grit around the devices and being subjected to roadway run-off containing salt.

Bridge Bearing Tilted and Corroded

Typically, when the decks of the bridges are rehabilitated or replaced, the bearing devices are also replaced, as required. In addition to the bridges included in the Bridge Deck Reconstruction and Rehabilitation Program, the bridge bearing devices that have deteriorated to the point that they require attention will be addressed separately in this project. Rehabilitation of these bearing devices is essential to ensure the continued structural integrity of the Turnpike bridges.

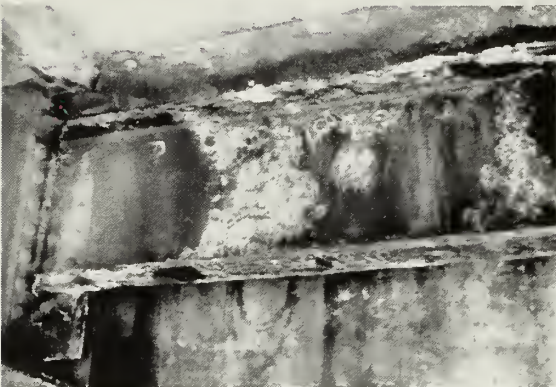
Corrosion of Structural Steel at Expansion Joint

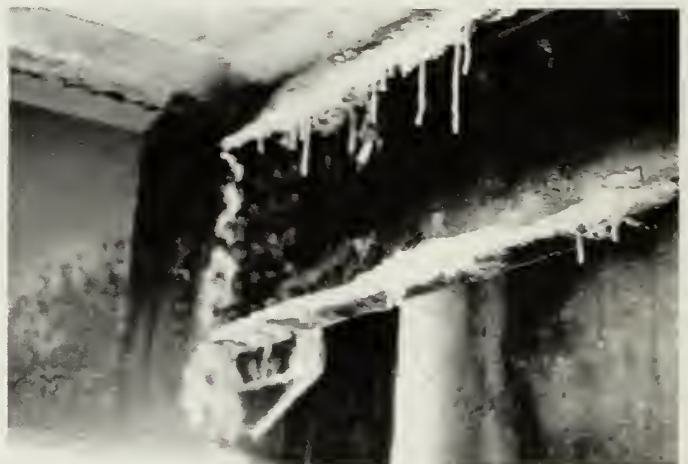
Corrosion of Structural Steel Resulting from Leakage through Deck

Bridges which are scheduled for Bridge Deck Replacement also will be cleaned and painted. Cleaning and painting for those bridges that are not scheduled for deck replacement will be performed on a priority basis under separate contract and coordinated with other bridge reconstruction activities wherever possible. Failure to perform this work on an accelerated basis can result in a more rapid deterioration of the structural steel and a dramatic escalation in the costs of the rehabilitation.

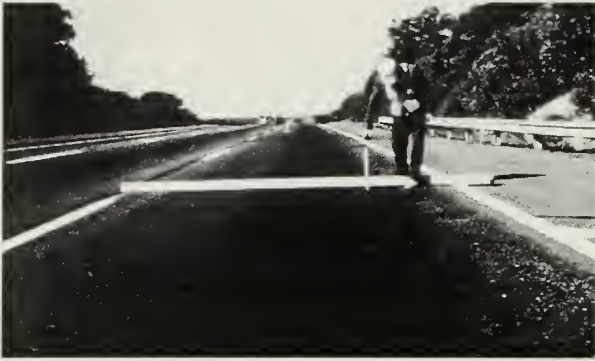
Pavement Rutting - Mainline Roadways

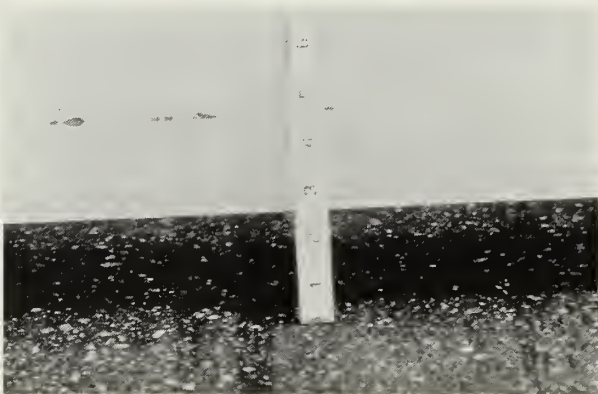
3" Rutting in Wheel Path

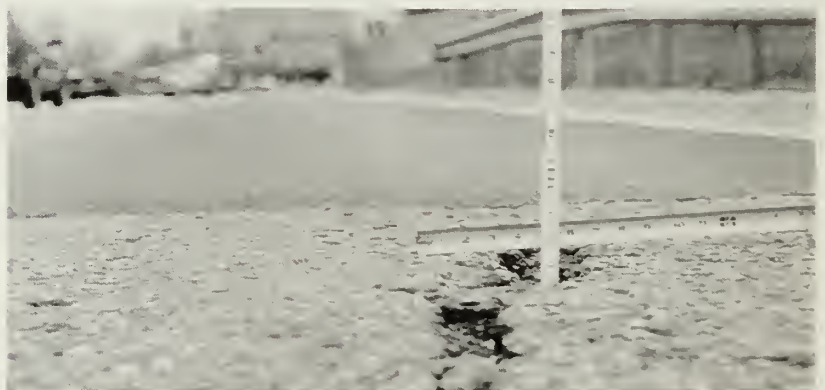
2" Deep Crack in 10 Year old Pavement

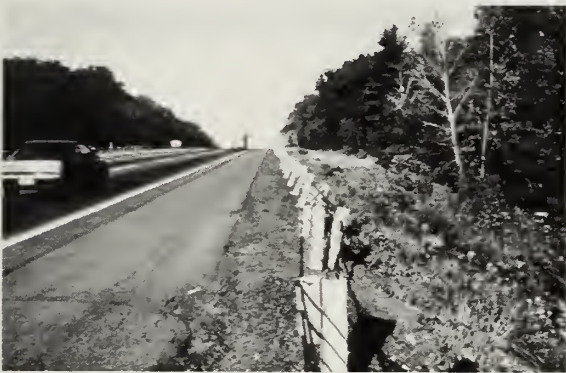
Section of Highway Guard Needing Replacement

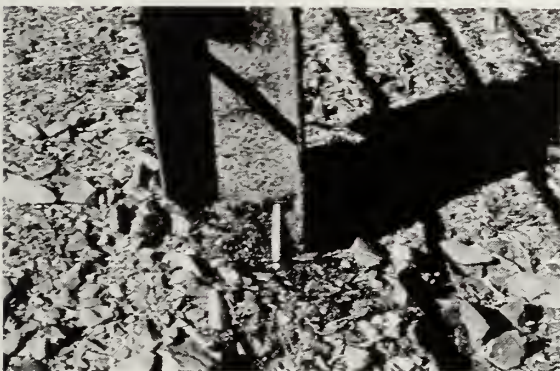
Severely Corroded Highway Guard Post

guard systems, such as the steel beam system used along the Turnpike, have proven their effectiveness at saving lives and reducing injuries. Although most of the original highway guard on the Initial Turnpike has already been replaced, there are still thirty-five miles of the roadway where the highway guard should be replaced to further improve safety on the Turnpike. The existing program of safety upgrades and improvements incorporating current standards for highway guard will be continued in conjunction with the resurfacing program.

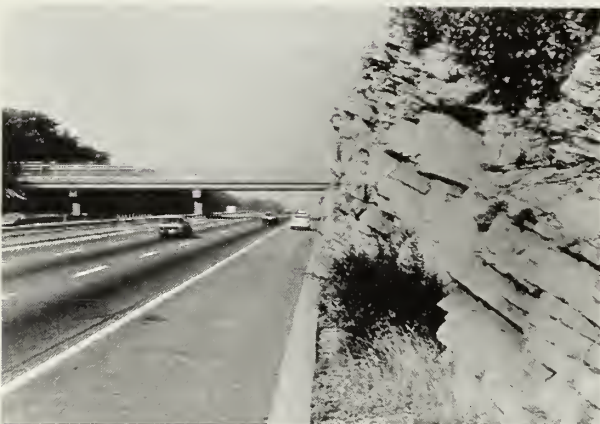
Rock Overhanging Barrier Wall

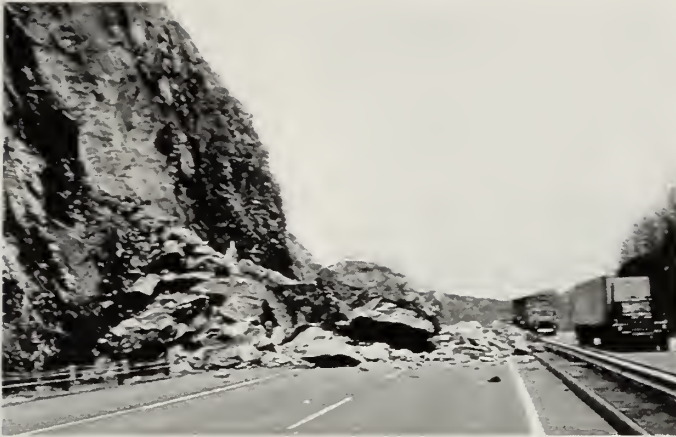
occurrence of falling rocks. A dramatic example of what can occur if these ledges go unattended is shown in the following photo which took place along the MassPike several years ago. A program to clear the most critical areas of the falling rocks was initiated in the 1970s and over the past decade a number of locations have been addressed. In a further effort to reduce the potential that other incidents of this proportion do not occur in the future, in recent years MassPike has engaged the services of geotechnical specialists from the engineering firm of Haley and Aldrich to assess the integrity of various rock formations along the Turnpike corridor and to recommend a list of priority sites to be addressed over the next several years.

Rock Slide onto Turnpike Roadway

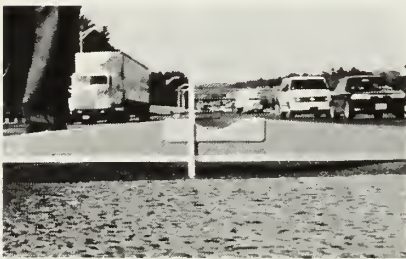
Wheel Rut at Toll Plaza Lane

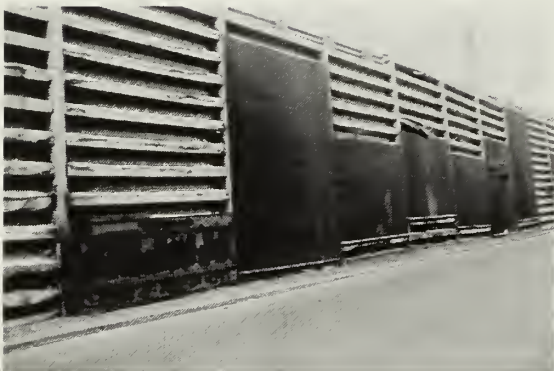
Metal Bin Wall with Temporary Repairs at Hudson Street (looking southeast)

Certain metal bin walls on the Boston Extension should be replaced at this time because of heavy rusting and corrosion. This corrosion creates holes which allow the fill materials to be washed out of the embankment. Metal bin type retaining walls at two locations on the Boston Extension are in need of repair or rehabilitation due to their deteriorated condition. One such wall, supporting Ramp F at Hudson Street at Interchange 24, is scheduled to be replaced under the Central Artery/Tunnel (CAT) project. Its current condition, however, makes it necessary to make temporarily repairs to the wall until it is replaced. Additionally, three other sections of metal-bin walls supporting the Turnpike at Interchange 19, adjacent to Conrail tracks, will be rehabilitated. The proposed work includes shoring the embankment, and constructing new precast concrete retaining walls to ensure the stability of Turnpike roadway embankments and protection of adjacent property.

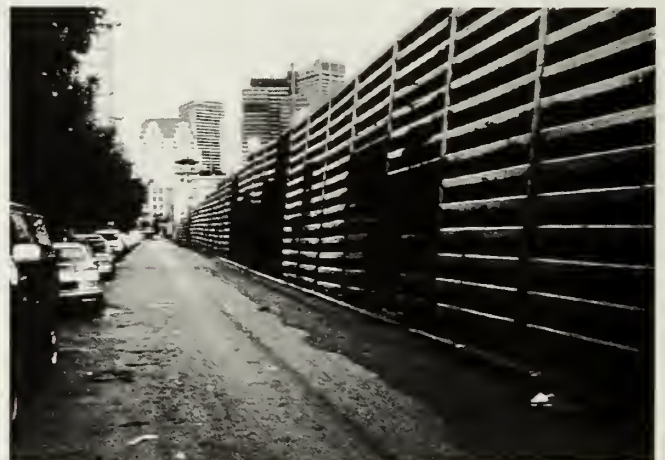
Metal Bin Wall at Hudson Street (looking north)

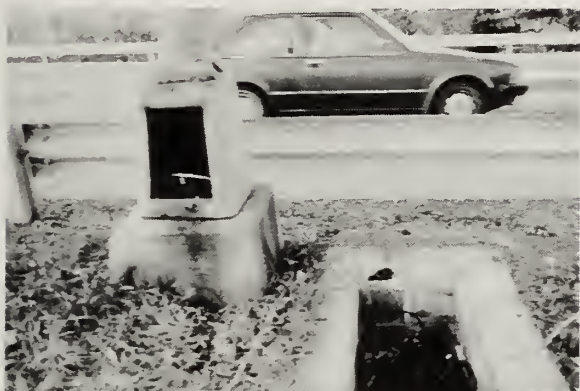
Deteriorated Roadway Lighting System Elements

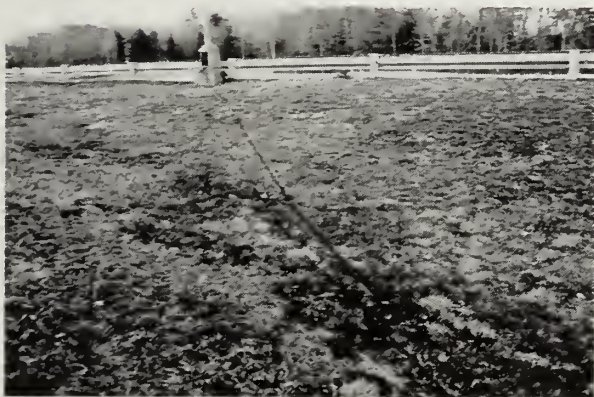
Deteriorated Roadway Lighting with Temporary Exposed Wiring

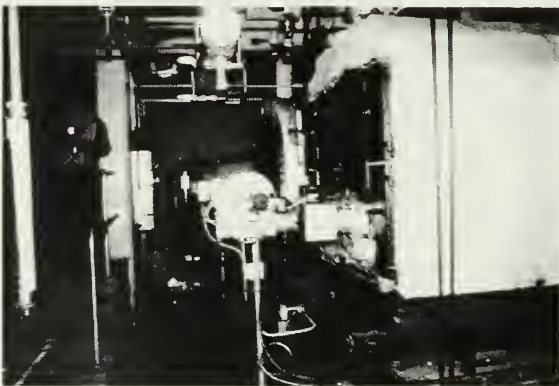
Existing Outdated Boiler Installation

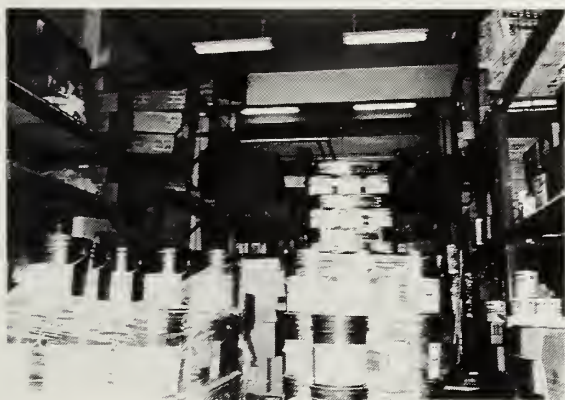
Overcrowding at existing Weston Storage Facilities
